# SHORE EROSION STUDY Technical Report

# Appendix

SHORELINE EROSION AND BLUFF STABILITY ALONG LAKE MICHIGAN AND LAKE SUPERIOR SHORELINES OF WISCONSIN

> DOUGLAS AND WESTERN BAYFIELD COUNTIES WISCONSIN POINT TO BARK BAY

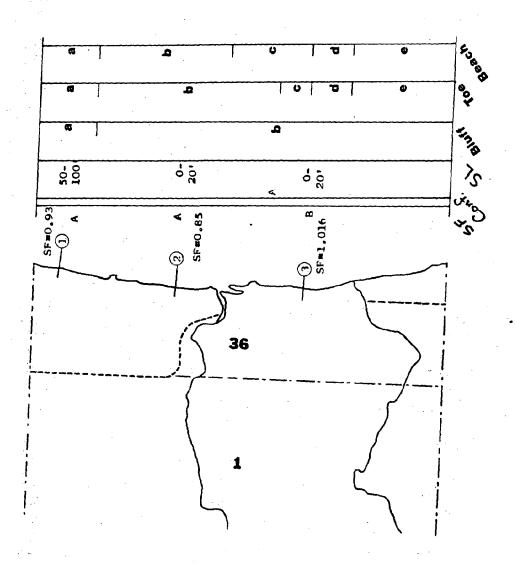
#### Sec. 36, T 49 N, R 13 W

The section is located a mile east of Wisconsin Point and is bisected by Dutchman Creek. The bluff is 50 ft. high, except at the streams, and extends throughout the section. At its western end, the bluff is failing by shallow sliding. It is poorly vegetated grass and alder being restricted to slump blocks moving downslope and is composed of red clay. The rest of the bluff shows only minor evidence of recent instability. It is well-vegetated with birch, alder, and grass that conceal the bluff materials. West of Dutchman Creek, the sandy beach is wide enough to protect the toe. Eastward, the beach thins considerably and the toe, composed of slumped red clay, shows marked instability. Where the beach is absent, a 10-12 ft. toe scarp is present; renewed bluff instability is expected in these areas. The beach west of Dutchman Creek is heavily used due to its proximity to Superior and ease of access.

- a) red clay; slumped; protected by beach
- b) clay, slumped, protected, vegetated with alder and grass or scarped at large slump blocks
- c) clays, slumped, partially protected, failing for 10 ft vertically by shallow sliding with 2-3 ft scarps at base unvegetated
- 'd) clays, slumped, unprotected from waves, failing by shallow sliding and mudflows with 8-12 ft scarps at base, unvegetated
- e) clays, slumped, partially protected, failing for 10 ft vertically by shallow sliding with 2-3 ft scarps at base unvegetated

- d) mostly absent (0-5 ft) wholely within wash/swash zone sand with occasional cobbles or boulders
- e) narrow (20-30 ft) wider west of stream (40-50 ft); coarse-medium sand; minor concentration of pebbles and cobbles 5-6 ft near water's edge concentration increases greatly eastward

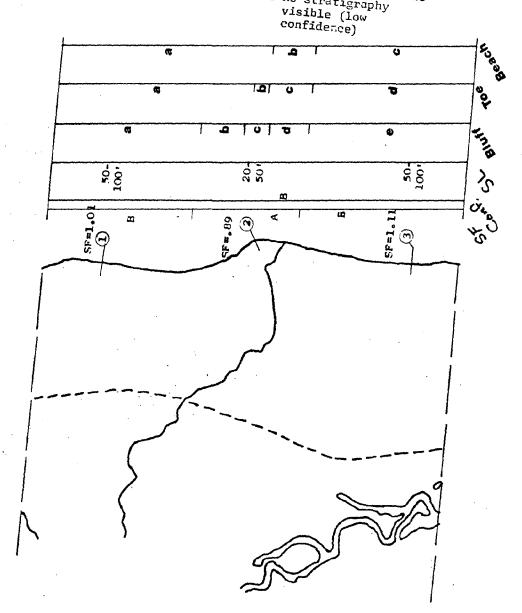
### Sec. 33, T 49 N, R 12 W

The section is located one and a half miles west of the mouth of the Amnicon River. The beach is present only rarely within this section. Where present it is at most 20 ft. wide and is composed of sand, often interfingered or perhaps underlain by clay like that in the toe. The bluff is 50 ft. high and only a very short subsection is well-vegetated and lacking fresh scarps. Failure is by shallow to moderately deep slides and by flows originating on the upper half of the bluff. In one subsection the bluff is actually vertical! Here, failure is by block fall. There appear to be two materials in the bluff - an upper red clay, which is less stable, and a lower browner clay, which seems to be stronger. A subtle break in slope can often be noted at the contact. The toe in this section is almost entirely unprotected from wave action. The toe material is the brownish clay, probably in situ. The shoreline of this section is rarely used.

- a) slumped or in situ clay (browner in color); mostly unprotected; scarp 2-18 ft high.
- b) protected slumped clay covered by vegetation
- c) unprotected slumped clay ("talus pile" from Bluff (d))
- d) slumped or in situ clay (browner in color); mostly unprotected; scarp 2-18 ft high

- a) discontinuous; mostly absent; if present up to 20 ft wide coarse sand with pebbles, cobbles and occasional boulders
- b) absent
- c) discontinuous, mostly absent; if present up to 20 ft wide coarse sand with pebbles, cobbles and occasional boulders

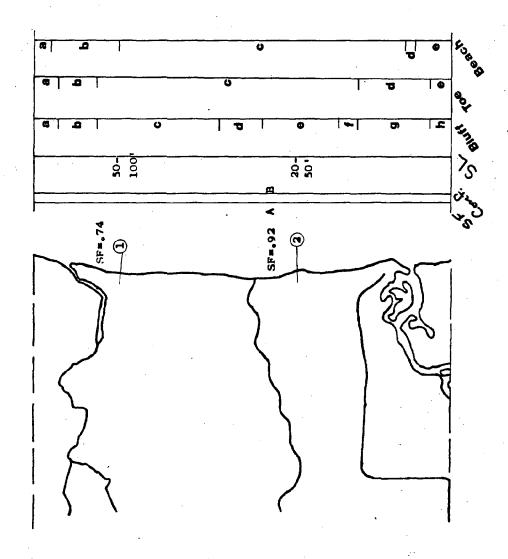
### Sec. 35, T 49 N, R 12 W

This section is located between the valleys of Hanson Creek and Middle River inclusive, a half a mile east of the Amnicon River. A good sandy beach, usually about 60 ft. wide, is present throughout most of the section. The bluff is quite discontinuous because of the streams which intersect the shoreline with wide valleys. Where well-expressed, the bluff is 55 ft. high, moderately vegetated, and failing by shallow sliding with some flowing from the upper part. The bluff materials are a brown clay overlain by a red clay but the brown clay is rarely exposed. Near the streams, the bluff height rises and falls quickly, to and from approximately 30 ft.. It is very well vegetated with little evidence of instability. A well graded slope is present at the west side of the Middle River. The toe is protected by the wide beach and is composed of slumped red clay, with infrequent exposures of in situ brown clay. There is public access at the west side of the Middle River, but no landing is present. Use is probably moderate to infrequent.

- a) 50 ft dropping to 0 ft; shallow slide and block fall; 0% vegetation, red and brown clay
- b) absent
- c) rising to 50 ft; eastward shallow slides; flows from top 0-5 to 40-50% alder and grass; two clay units
- d) 30 ft falling to 0 ft; no failure seen; vegetation 95-100%, birch, alder, grass, horsetails
- e) 50-55 ft; shallow sliding and flows from top; vegetation usually 0-20% alder grass slumped clay
- f) 30 ft falling to 0 ft; no failure seen; vegetation 95-100%, birch, alder, grass, horsetails
- g) absent gentle graded slope well vegetated
- h) Oft rising to 30 ft; shallow slides and some block fall; 10-20% tree-clumps and horsetails, slumped clay

- a) unprotected, in situ brown clay
- b) absent
- c) protected slumped clay, vegetated
- d) absent; gentle graded slope well vegetated
- e) protected slumped clay

- a) mostly absent; interfingered with clay flows
- b) 40 ft coarse sand with pebbles concentrated near water
- c) 60 ft; coarse sand, pebbles near water
- d) absent-Middle River
- e) 60-80 ft coarse sand; pebbles near water; includes spit

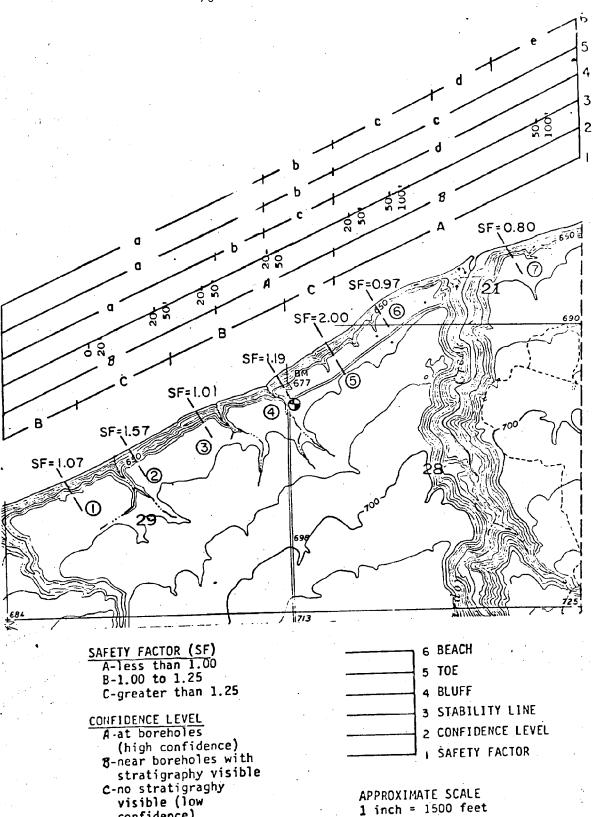
### Borehole Site 2

Borehole Site 2 is located in Reach 2. It begins 0.5 miles east of the Poplar River and ends 0.5 miles east of Bardon Creek. The site includes 2.2 miles of shoreline in Sections 29, 28, and 21 of Township 49 north, Range 11 west in Douglas County. This study area is comprised of high bluffs with actively eroding slopes. The bluffs average 70 feet in height and are dissected by several gullies and streams.

Erosion in the western three-quarters of Section 29 occurs in the form of shallow translational slides and flows. Surface water has played, and is playing, an important role in eroding these Douglas County bluffs. Cirque-shaped basins are created by drainage patterns which channel surface water across the bluff. As a result, the vegetation on these slopes has been stripped by this active erosion. A distinct change in erosional mode occurs in the eastern quarter of Section 29. Massive rotational slump blocks, sometimes encompassing the entire bluff, have been observed. The western half of Section 28 appears to be relatively stable since the bluffs remain fully vegetated and there is little evidence of slope failure. East of these stable bluffs, bluff profiles change dramatically. In this area,

- a) 0 to 20 feet, sand
- b) 30 to 70 feet, sand
- c) 10 to 20 feet, sand
- d) 20 to 50 feet, sand
- e) 10 to 20 feet, sand

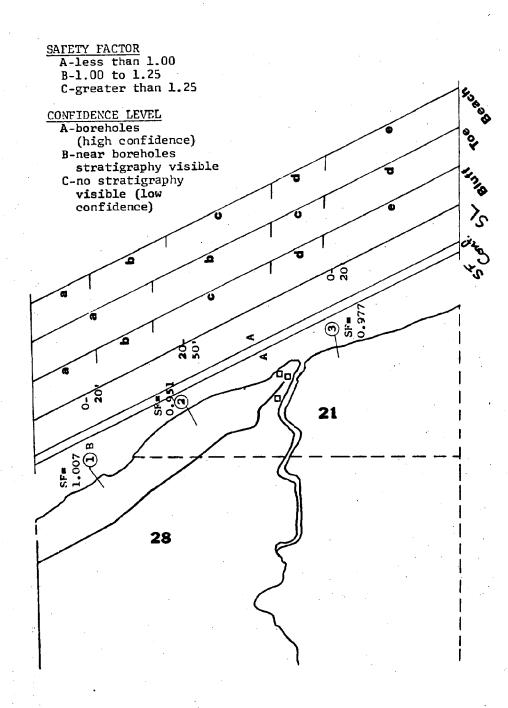
# Sec. 28/21, T 49 N, R 11 w

The section lies to the east of Peterson Road and is bisected by Bardon Creek. De Vries Road runs parallel to the shoreline along the bluff top west of Bardon Creek. Red clay is a major constituent of the bluff. Beneath this material lies 20 feet of brown clay. Toward the western end, a brown silty material appears in a ravine 10 ft. above the lake level. Its upper contact with the brown clay rises to the east until it is 20 ft. above the lake surface. Though covered many places east of Bardon Creek, this silty unit forms a prominent bench in the slope profile as seen in RP 28/21-3. Throughout the section, shallow slides are the dominant form of failure. This material accumulates at the toe to be eroded by waves. Where the silty unit forms a bench, the sliding material forms chutes, flowing over the bench and fanning out at the base into a lobe. The beach is sandy and of variable width. It widens at the mouth of Bardon Creek and is absent where flows and slides have covered it. Vegetation is very sparse throughout the section and consists only of trees and sod slumped from the crest. A few summer cottages abut DeVries road but none have developed access to the shore. At the end of DeVries, a cottage with several smaller buildings is present right on the lake. A cement pier and some boulder rip-rap have been constructed here. Public use is limited by poor access.

- a) 3-5 ft; slumped red clay; horsetails and sod clumps; wave protected
- b) rounded, un-vegetated, slumped red clay of mudflows; in places hit by wacks
- c) toe absent-Bardon Creek
- d) slumped red clay, mudflows, unvegetated, un-protected from waves

- a) 20-25' wide; sand with scattered pebbles; width constant
- b) 8-15' wide; sand with scattered pebbles
- c) 0-8' wide; width variable; sandy with log litter and occasional boulders
- d) 8-50' wide; widents at mouth of Bardon Creek; sandy
- e) narrow sandy swash zone or beach absent: scattered driftwood

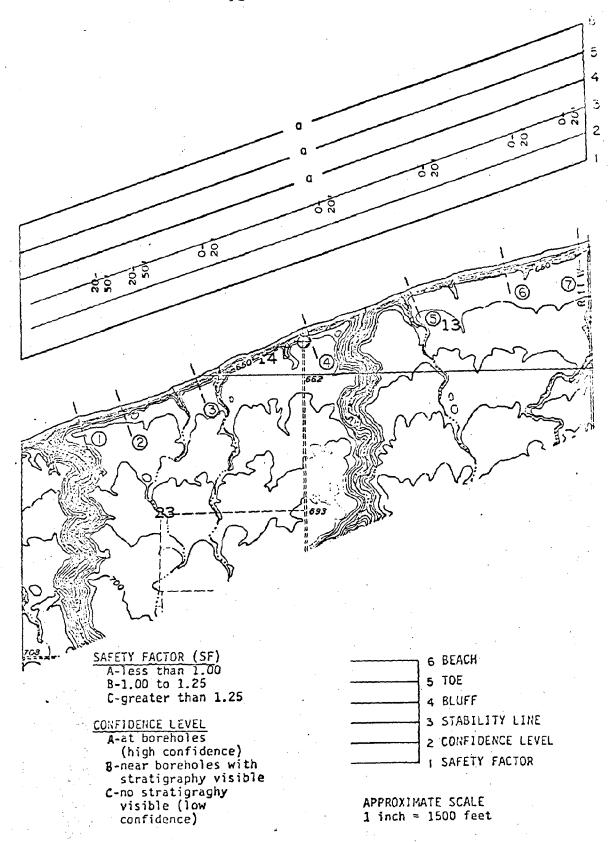
# Borehole Site 3

Borehole Site 3 is located in Reach 2 and extends from west of Haukkala Creek to a point midway between Nelson and Fisher Creeks. This study area includes 2.2 miles of shoreline in Sections 23, 14, and 13 in Township 49 north, Range 11 west in Douglas County. The shoreline is dominated by erodible bluffs which range from 50 to 65 feet in height. Haukkala Creek, Nelson Creek, and three unnamed streams dissect these bluffs.

The bluffs at this site have geological units similar to those identified at Site 2 one mile to the west. In the western end of the site, the two clay units are underlain by a unit of well-sorted sand (see Profile 1).

Further to the east, the lower, browner clay is intermittently exposed at the bluff toe. The two-clay units are occasionally separated by a thin lense of sand (see Profile 2). Gray clay, which may represent an inclusion within the silty-clay soils, is present at one location within the study area (see Profile 6). Bluff failures primarily in the form of large-scale rotational slumps result from the continual erosion of the bluff toe (see Profiles 1 and 4). Beaches, generally less than 10 feet in width, provide little protection from this wave action. The removal of vegetation by large-scale rotational slumping has increased the susceptibility of the site to translational slides and saturated earth flows.

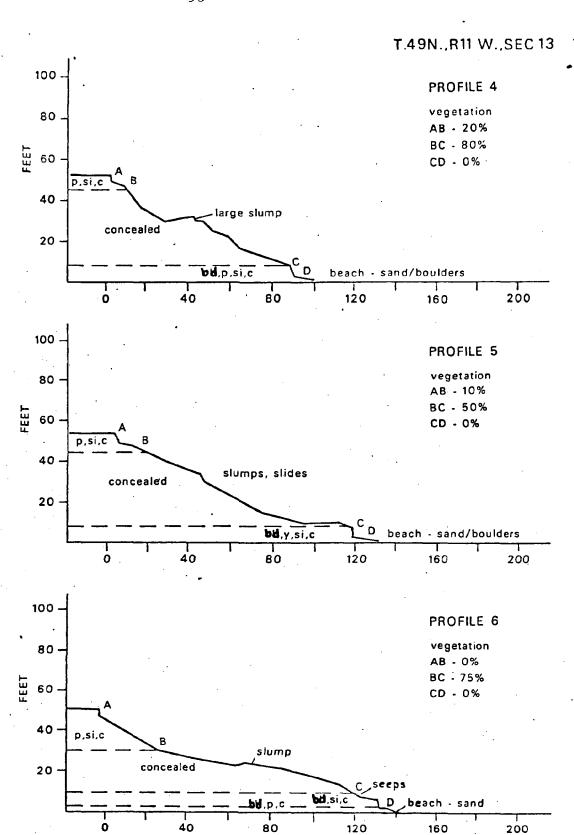
# T.49N.,R11 W.,SEC 13

The section is located four miles west of the mouth of the Brule The beach is not present throughout the section, being absent or nearly so for about a quarter of a mile in the middle. West of this it begins at 15-20 ft. in width widening to 40 ft. Eastward it reappears at 10-20 ft. for the remainder. When present, it is sandy and boulders are quite frequent throughout. The bluff declines slowly from 50-55 ft. in the west to 30-40 ft. in the east and is moderately to well vegetated throughout. It is failing by two mechanisms. At the west end, repeated shallow sliding predominates, producing an evenly-sloped hummocky surface. At the east end, failure is by large, single-block sliding of moderate depth; this produces a broadly stepped profile. A long subsection in the middle shows elements of both mechanisms. The bluff is composed of a red clay, mostly slumped, covering a brown clay which underlies it. The toe is poorly to partially protected on the average and is composed of slumped red clay. Although there is reasonable access to the section, use seems to be limited.

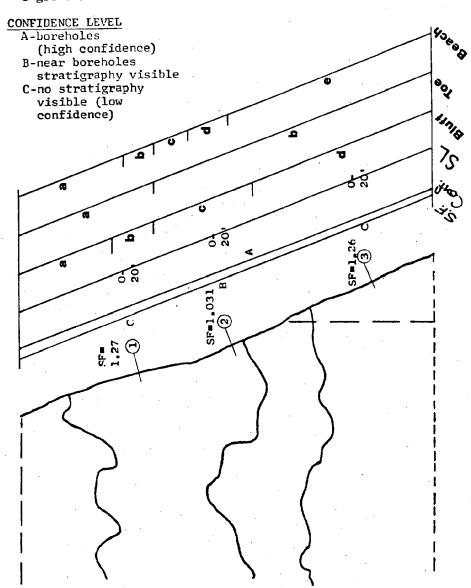
# SEC 23/14 T49 N R11 W

This section is located to the west of Windy Lane, a road which meets Highway 13 one mile west of Cloverland. The section is bisected by Haukkala Creek. In this section, the bluff height slowly decreases steadily from 55 ft. to 45 ft. Similarly, a silty unit, which occurs in the sections to the west, become less visible to the east and is absent by the center of the section. The silty unit here contains a large amount of sand. Failure in this unit is uncommon and, when exposed, has an eroded appearance. The overlying 20 ft. of brown clay and 30 ft. of red clay are similar in type of failure. Occasionally, a large rotational slump occurs, but shallow slides are more common. -In the more vegetated reaches, occasional scarps are noticeable, signifying renewed failure. In the western third, vegetation is sparse and consists of horsetails, and trees and grasses being rafted down from the failing crest by shallow slides. In the remainder of the section, though not entirely stable, grass and alder cover 80-90% of the hummocky bluff face. In some subsections the beach is wide and the toe is mostly protected. In the other subsections, the beach width is variable and often absent, leaving the toe unprotected from waveerosion. Access to the shore in the section is poor. No development is present at this time along the bluff.

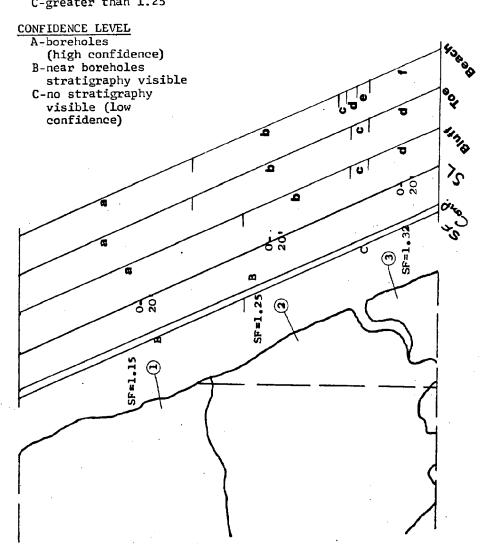
#### SEC 17/8 T49 N R10 W

This section is located 2 miles west of the mouth of the Brule River. West of Smith Creek the beach is either absent or frequently interrupted. Where present in these subsection, it is sandy, 10-20 ft. wide with boulders offshore throughout. A 40-60 ft. wide sandy spit is built across the Smith Creek estuary, some of which is vegetated. East of Smith Creek the beach narrows to 20-30 ft. The bluff is 35-40 ft. high and moderately to well-vegetated throughout. Failure is by shallow sliding with blocks of varying size and number, and by flowing. In the eastern half, there is a single, large block, and the sliding is perhaps the deepest here. There is additional sliding and flowing above and below this block. Between this subsection and Smith Creek, the sliding becomes quite shallow and is much mixed with flowing. East of Smith Creek, numerous shallow slides are present above a subdued larger block. The bluff is composed of a red clay, which is underlain by a brown clay. The toe is unprotected where the beach is absent, partially protected elsewhere; but it is only wholely protected east of Smith Creek. It is composed of slumped clay. Access to the section is quite poor.

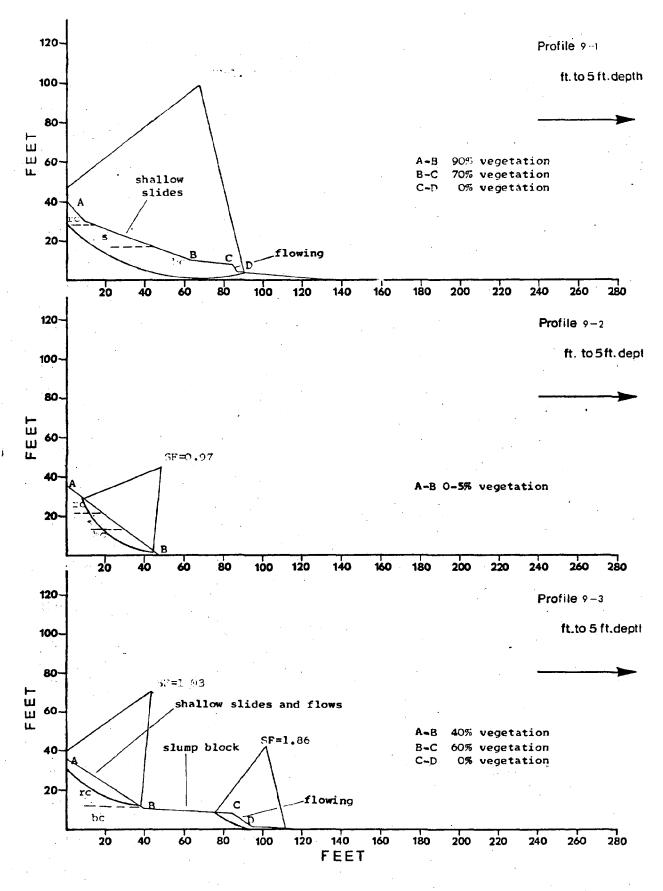
T.49 N., R. 10W., Sec. 9

This section is located just west of the mouth of the Brule River. A sandy beach 30 ft. wide, is present along the western half of the shoreline. It then becomes narrower (15-20 ft.) is often interupted and then widens quickly to 80 ft. The bluff is 40 ft. high to the west declining 35 ft. just west of the estuary after which it is absent. Subsections to the east and west ends are moderately to well vegetated and failing such that one large slump block is well preserved. Shallow sliding of much smaller blocks occurs on the scarp above the block while the scarped toe is more prone to flowing. A short subsection toward the middle is more poorly vegetated and is failing by numerous shallow slides and flows of small scale. The bluff is composed of a red clay, which is underlain by a browner clay. In places medium-coarse sand interbedded with silts and clays may be found between them. These relationships are partially obscured by the slumps and vegetation. The toe is scarped and composed of slumped and in situ clay along the western three-quarter. The eastern quarter is well-rounded and vegetated. There is good access to the very small western-most portion of the shore but the estuary is unpassable at present.

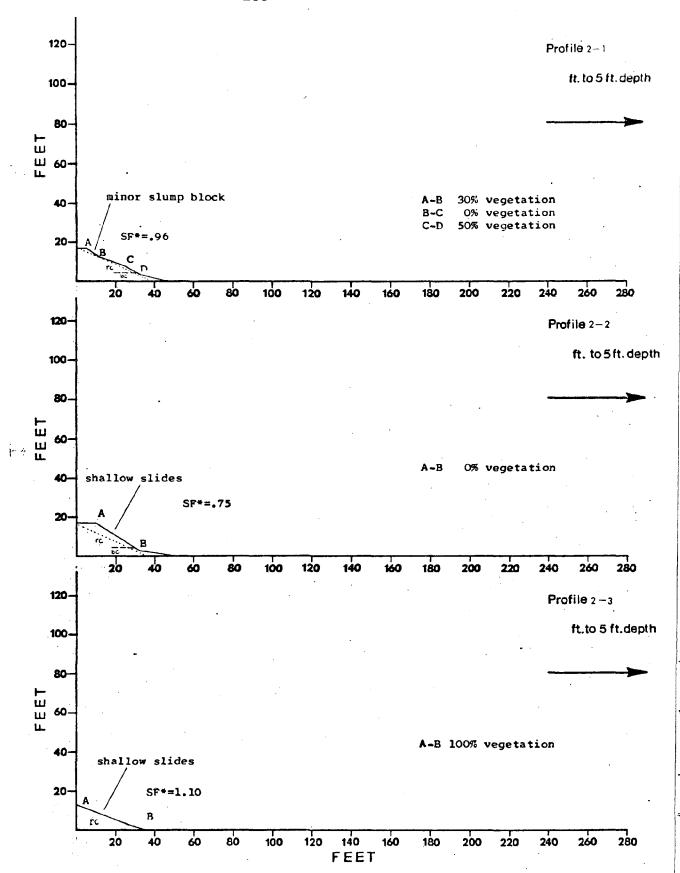
T.49 N., R. 10 W., Sec. 2

This section is located just west of Brule Point, about one mile east of the Brule River. A sandy beach is present spordically along the shoreline. Subsections of 15-20 ft. in width alternate with subsections of 15-20 ft. in width alternate with subsections of near or total absence. The beach is quite wide just east of the stream estuary which bisects the section, but it narrows steadily thereafter. The bluff is 15-20 ft. high at the western end and declines slightly to 10-15 ft. at the estuary. Following a subsection of no bluff (graded, gentle slope) it rises again to 10-15 ft. and then more slowly to 15-20 ft. It is failing by shallow sliding and flowing; but the degree of activity, as indicated by the amount of vegetation, varies. Subsections with 80-100% vegetation alternate with subsection having 20-40%. The bluff is composed of clay, mostly slumping. The toe is composed of slumped clay and its degree of protection relates directly to the width (or absence) of the beach. There is reasonable access to the middle of the section by an unimproved dirt road, but use seems to be infrequent.

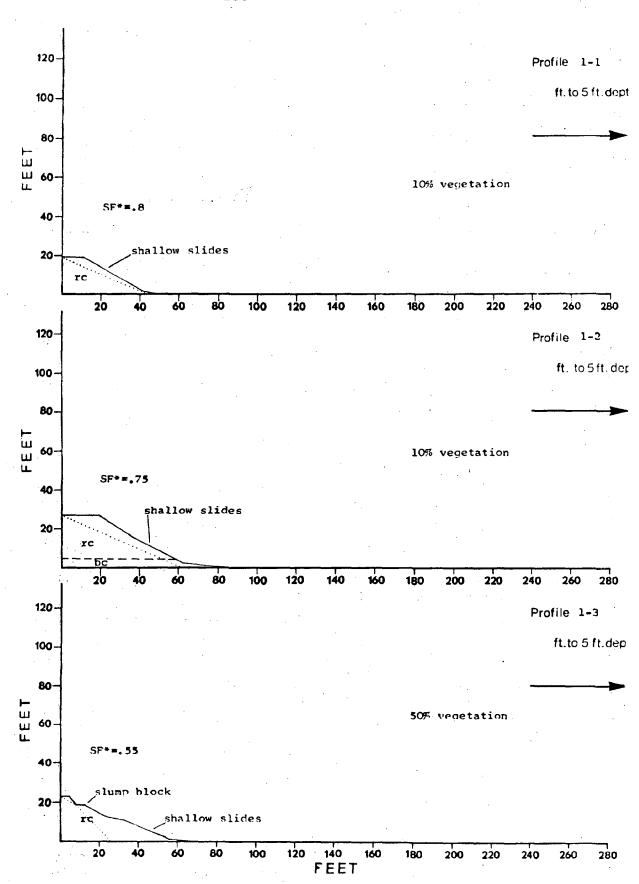
T. 49 N., R. 10W, Sec.1

This section lies on the eastern side of Brule Point and is the eastern-most section of the shoreline in Douglas County. Throughout the section, the bluff materials consist predominantly of red clay. In two isolated locations, a browner clay of similar texture occurs, but does not influence in the vegetation or failure style. In the western part of the section where vegetative cover is 100%, the bluff is stable and has a smooth, moderately steep profile. Farther east, vegetation decreases and the clay is failing in small rotational slumps and shallow slides. These slides scallop the bluff crest and carry sod clumps and trees down slope. In the eastern-most -portion, the bluff may be unvegetated and very steep with shallow slides and flows. The crest of the bluff lies 20-30 ft. above the lake and is fairly even, rising steadily towards the east. The toe of the bluff is unvegetated, except for the western portion and the occasional sod clump brought down from the crest. It is composed of slumped red clay. It is protected by a wide sand beach except in a few subsections where waves attack the toe directly. The shoreline, here, is undeveloped and is used seldom. Access is poor and only from unimproved dirt roads which lie in the adjoining sections.

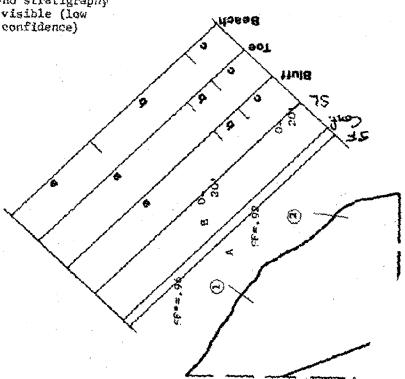
#### Sec. 33, T 50 N, R 9 W

- a) 80-100% vegetated, birch and firs; Medium scale rotational slumps in red clay over 1-10' feet of red clayey sand; 20-25' high with even crest; bedrock at toe in west half.
- b) 10% vegetated, birch clumps sliding downslope; shallow slides in shallow slides in red clay with bedrock occasionally at toe; 20' high
- c) 40-50% vegetated, birch and sod clumps; small slumps; no bedrock at toe; 15-20' high tapering off to east

- a) 0-10 ft; sandy with boulders; boulder concentration increases to the east
- b) 0-5 ft.; cobbly and bouldery; beach often replaced by bedrock 1'-5' exposed
- c) 20-40 ft, widening towards east and Iron River; sand with pebbles; no bedrock

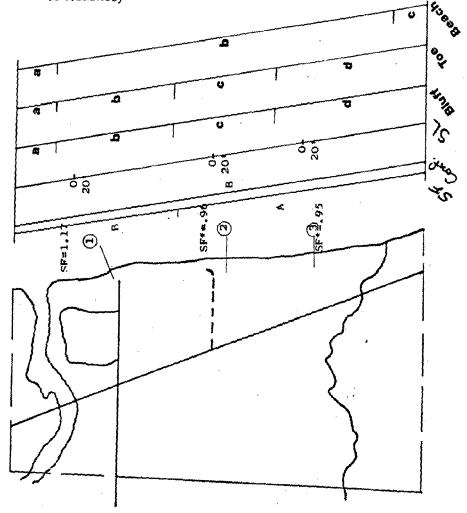
#### Sec. 34, T 50 N, R 9 W

- a) No bluff, Iron River
- b) 40% vegetated; birch and grass; red clay; small slumps and shallow slides; 20' high
- c) 40% vegetated grass; red clay over 2 ft. of clayey sand till; long narrow shallow sod blocks sliding downslope; 20-25' high
- d) 0% vegetated, occasional tree clumps in east end where crest is vegetated; red clay over sand; shallow slides and flows; 30-55' high, sand forms break in slope

- a) Iron River; 50' sand beach to west, cobbly swash zone to cast
- b) 15'-20 ft., occasionally absent; sandy with cobbles and scattered boulders immediately off shore
- c) 5-10 ft., sand and cobbles with boulders

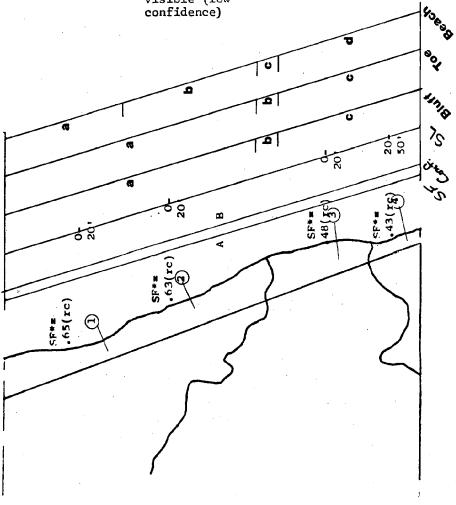
#### Sec. 35, T 50 N, R 9 W

- a) 0-20% vegetated, sod and birch clumps, red clay over red sand till; till forms a break in slope; 20-30 feet.
- b) Jardine Creek, no bluff
- c) 0% vegetated red clay, sandy till, disturbed bedrock over bedrock rilled with slides; 20' high; > 100% slopes

- a) 15 ft.; sandy with occasional boulders
- b) 5 ft; cobbly and sandy with occasional boulders
- c) Jardine Creek
- d) 10 ft; cobbles and boulders

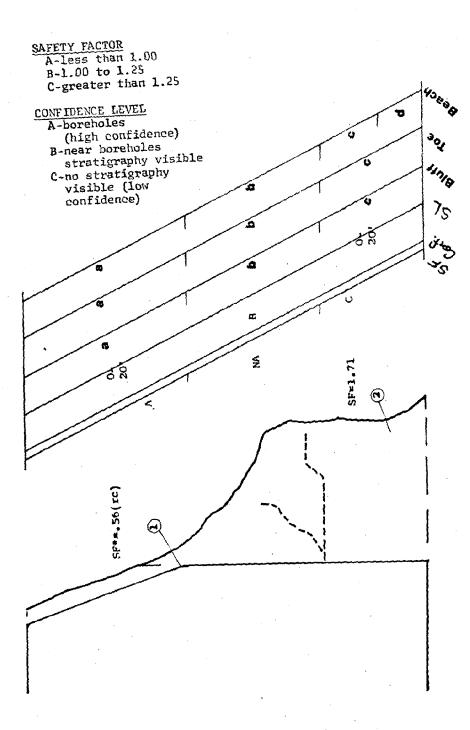
#### Sec. 36/25, T 50 N, R 9 W

- a) 0-20% vegetation, birch clumps; red clay over disturbed bedrock occasional cobbly sandy till; eroded with clay flows; bedrock in toe and occasional wave beaten; 20-25 ft
- b) 0% vegetation; red clay over bedrock; 20' with Bedrock up to 15'
- c) 0-10% vegetation, tree clumps; red clay over find sand and gravel; rilled with shallow flows; 20-30' high

- a) 5-20'; cobbly with occasional sandy streatches and scattered bedrock outcrops
- b) bedrock with occasional small sand pockets
- c) 20-30'; sand and pebbles with scattered boulders and cobbles
- d) 5'; cobbles and boulders

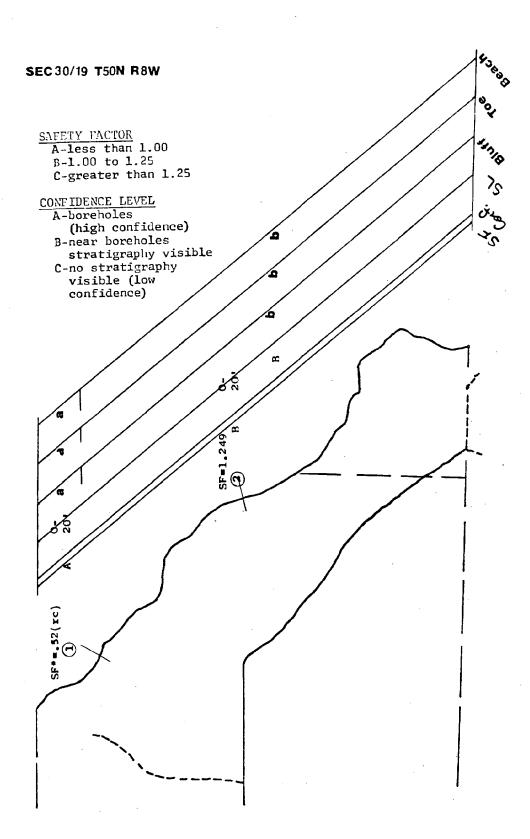
### Sec. 30/19, T 50 N, R 8 W

- a) 10-20% vegetation, shrubs in ravines and occasional tree clumps; shallow slides and rilling; red clay over sand with gravel lenses; bedrock occasionally at toe and hit by waves; bluff steep 25-30' high
- b) bedrock dominated bluff with up to 10' of unconsolidated material (red clay and/or sand with gravel) resting on 5-15' of exposed bedrock; 20' high with little vegetation

- a) 5-25'; sandy and cobby with scattered boulders and occasional bedrock
- b) bedrock at water level with occasional cobbly pocket beaches

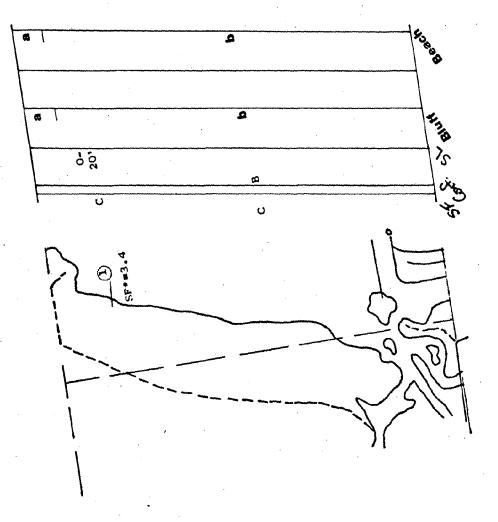
# Sec. 20/29, T 50 N, R 8 W

- a) Low bench of red sandstone, 10' high and wave attacked
- b) no bluff

- a) beach absent
- b) wide beach; 15' with steep sand berm, with 50' of grass backed by trees behind beach. Breakwater and light at eastern end for Port Wing Harbor

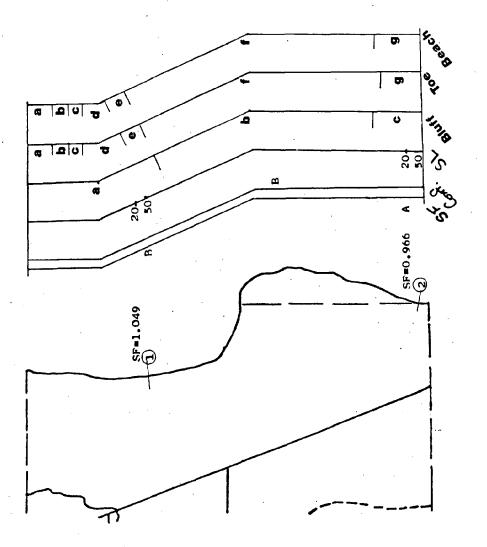
### Sec. 7/6, T 50 N, R 7 W

- a) 180 ft dropping to 100 after northward bend; sand with gravel lenses; rilling and gulleying; vegetation as little as 0-10%; half to two-thirds is 70-90% tall birch and cedar with undergrowth
- b) 100 then 70 ft after eastward bend; sand and gravel over bedrock the latter is 1/2 of bluff height; there are watercourses graded to rock lip; occasional failure by block fall; vegetation 100% birch, cedar, fir, alder along the top of the bluff.
- c) 70 ft; bedded sands and silts; shallow sliding and gulleying; 40-70% vegetated; clumps moving downslope, birch and alder

- a) 15-18 ft bedrock
- b) sand, protected
- c) 15-18 ft bedrock
- d) sand; protected
- e) sand, poorly protected
- f) 4-40 ft bedrock
- g) sand, protected

- a) bedrock
- b) 15-20 ft; coarse sand with occasional cobbles and pebbles
- c) bedrock
- d) 20-25 ft; coarse sand
- e) 1-2 ft; cobbles and boulders; bedrock just underwater
- f) bedrock
- g) 45-60 ft; coarse sand, pebbles at shore, granules in swash zone

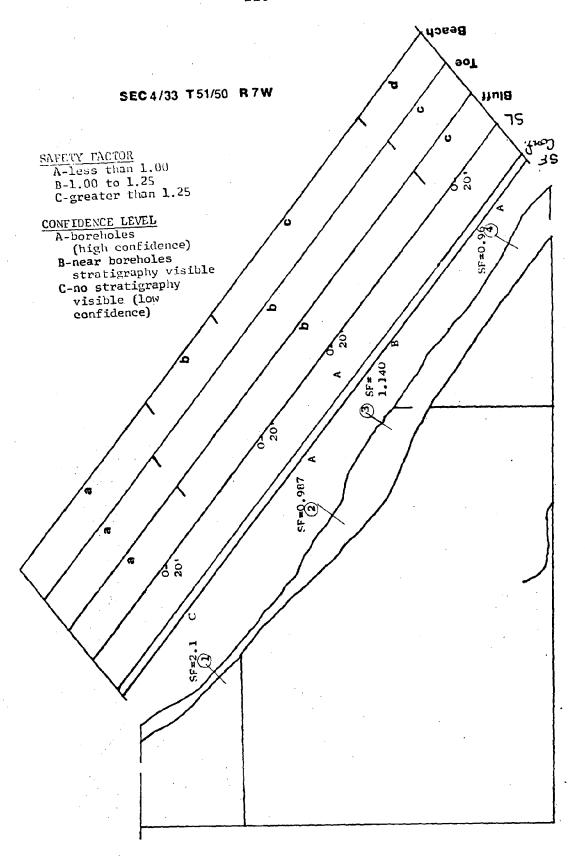
### Sec. 4/33, T 50/51 N, R 7 W

- a) no bluff, occasional rip-rap; protected
- b) vegetated, protected
- c) vegetated, protected some talus cones of swamped debris

- a) 20' wide; sandy with occasional culvert; two piers
- b) 15' wide; cobbles and pebbles with scattered boulders
- c) 5' wide; cobbles of scattered boulders
- d) 10-20' wide; cobbles and pebbles; occasional boulders

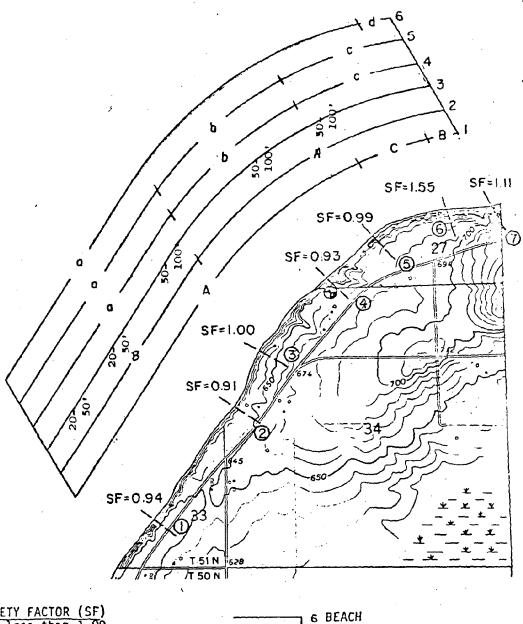
Erosion along this coast occurs as the result of direct wave attack on the bluff toe. These slopes fail by translational slides and flows.

A second form of coastal erosion at this site is gullying. Numerous ravines dissect the bluff face and are actively being enlarged by surface water drainage. One gully north of Profile 4 is being enlarged at a rapid rate as the result of land management practices. A roadside ditch is channeling large volumes of storm water into the gully which, in turn, erodes bluff soils. Without some corrective measures, the road may become endangered over the next three years.

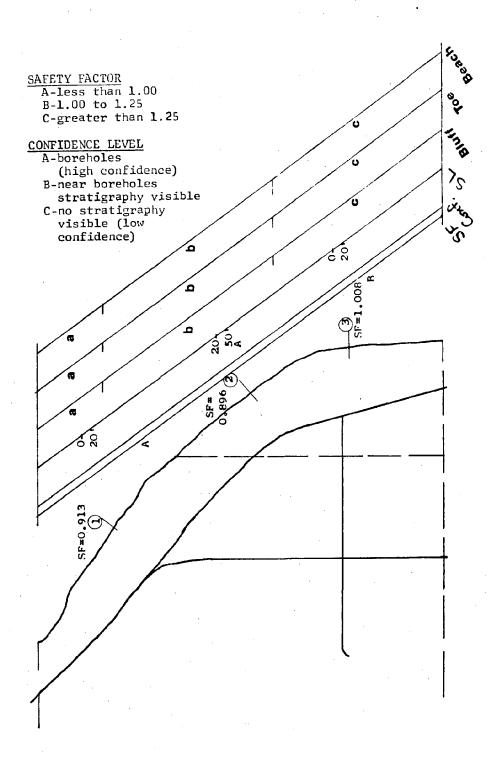
### Sec. 34/27, T 51 N, R 7 W

- a) 25-40' high bluff; red clayey sand with clay on top and occasional clean sand beds throughout; 60-80% in birch and shrubs; occasional shallow slides
- b) steep (45°-90°) slopes in hard dry poorly sorted sand; eroded by slope wash, occasional debris flow, and block falls; usually 3-4' of sandy clay at top with overhanging poor bound crest. Farther east, seep failures occur; 40-50' high
- c) steep high bluff in sand and clayey sand; sandy clay occasionally at crest; 60' high; Densely vegetated on scarp and in ravines but no vegetation on scarp faces; shallow sand flows and rilling

- a) occasional unprotected toe; well vegetated occasional with smallfans of slumped material
- b) sand talus and flow fans; protected and sparsely vegetated
- c) toe occasionally unprotected; flow fans

- a) 0-5 ft wide; sand over cobbles; numerous slumped trees; occasionally absent
- b) 10-20 ft; cobbles with sand and scattered boulders
- c) 3-10 ft; variable, sandy and cobbly; numerous fallen trees

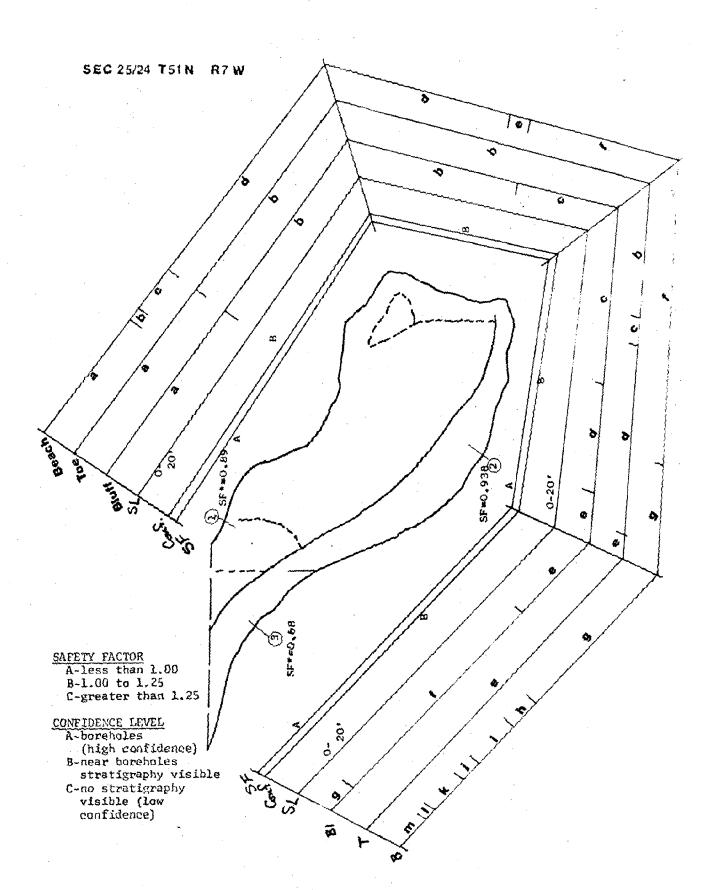
#### Sec. 24/25, T 51 N, R 7 W

- q) 3-5 ft. little failure noted; 80-100% birch, poplar, fir, cedar

- a)5-15 ft cobbles with boulders; often interrupted by slide blocks
- b) 10-20 ft coarse sand with cobbles
- c) 5-15 ft cobbles with boulders; often interrupted by slide blocks
- d) bedrock no beach
- e) 5-15 ft cobbles with boulders; often interupted by slide blocks

- f) bedrock- no beach
- g) 5-15 ft cobbles with boulders; not as interupted by slide blocks
- h) 10-20 ft coarse sand with cobbles and two concreate and wood piers
- i) 5-15 ft cobbles with boulders; less interupted by slide blocks
- j) 10-20 ft coarse sand with cobbles and one pier at south end
- k) 5-15 ft cobbles with a short portion cribbed with wood and less interupted by slide blocks
- 1) 10-20 ft coarse sand with two piers, a retaining wall between and a wood crib at south end
- m) 5-15 ft cobbles with boulders; less interrupted by slide blocks

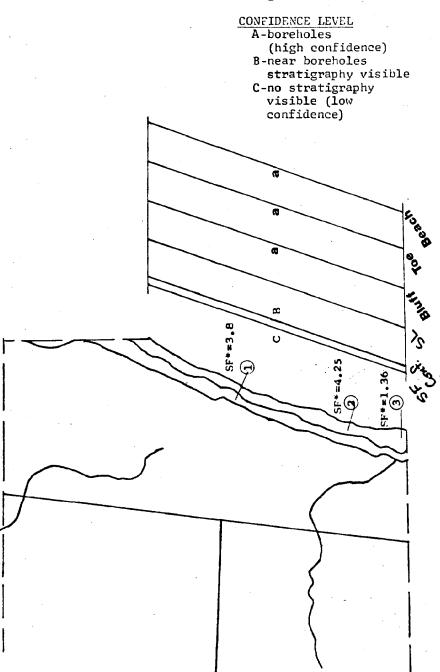
Sec. 1, T 50 N, R 7 W

a) 20-30 ft; medium sand; some horsetails on backbeach
